# CITY OF KINGSTON WATER MASTER PLAN

CONDITION ASSESSMENT REPORT - WATER

### **Final Report**

Project n° : 151-02944-00

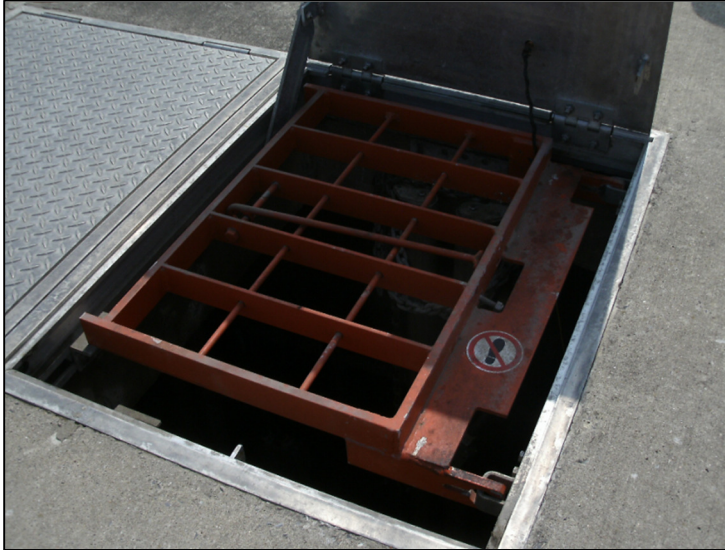
Figure 7-1 Palace Road PS – Safety Grate (Photograph)

Safety grating would be a valuable addition to booster station hatches and any other access point where fall prevention would improve safety at the facility. During times when hatches are opened for inspection, these safety gratings will provide an extra preventative measure to avert staff or members of the public from falling through access ways. Refer to Figure 7-1 below.

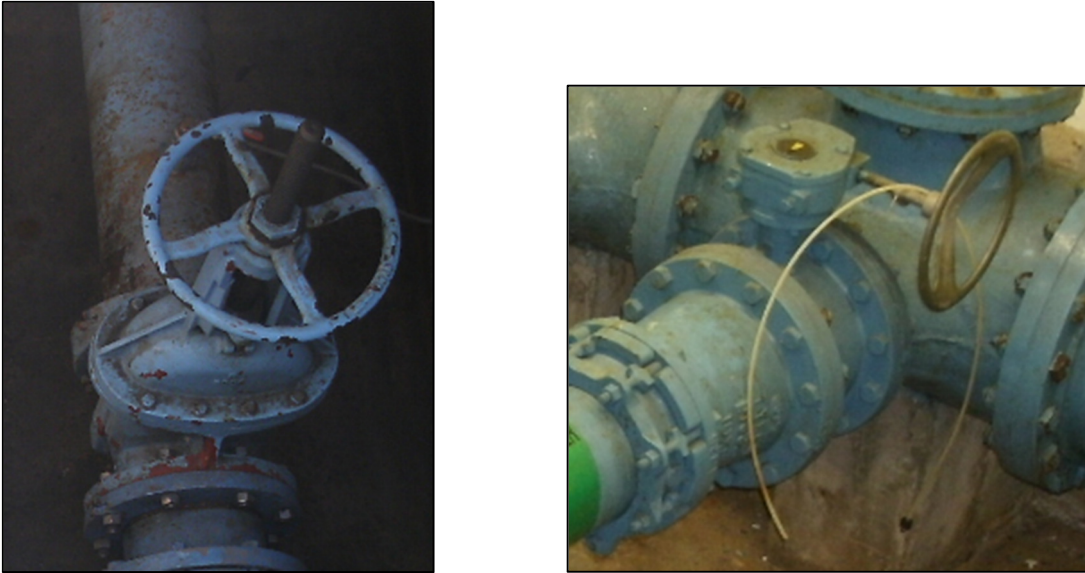
**Figure 7-2 Isolation Valves (Two Photographs)**

In most cases, valves do not appear to be maintained until there is a repair required. Turning the valves on, on a regular basis, to keep the valve in a good state of repair will allow operators to control these valves without difficulty. Refer to Figure 7-2 below.

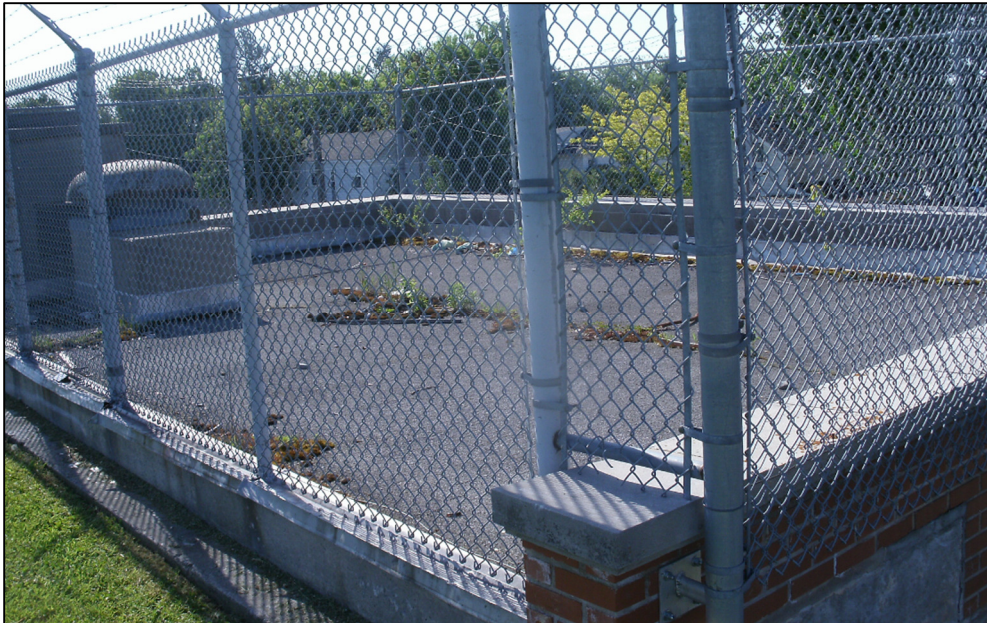
**Figure 7-3 Third Avenue Res/BS roof (Photograph)**

Although the type of roof varies between locations (flat/pitched) they appear, from visual inspection, to be relatively new in most cases. WSP's opinion is that all roofs will need replacing within a 10-25 year period and a review of the roofs should be completed separately to outline which roofs should be replaced and at what time. This review will allow UK to prioritise work, efficiently budget, and obtain manageable fees from contractors by combining the work into a bigger contract, then proceeding to upgrade the roof of each facility as required. Figure 7-3 below shows an example of a City of Kingston water res/BS roof.
