# CITY OF KINGSTON WATER MASTER PLAN

CONDITION ASSESSMENT REPORT - WATER

### **Final Report**

Project n° : 151-02944-00

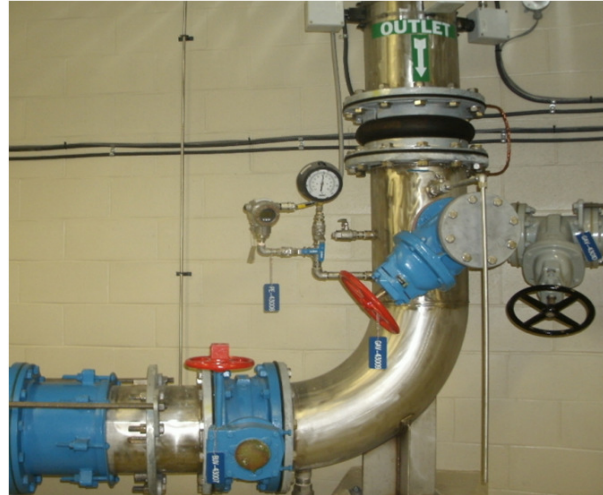
## 7.4.2 Innovation Drive EST

Reliability Rating 6.0 Overall Rating B

Total Facility Risk 3.4 /5 Total Equipment Risk 1.8 /5 Condition rating 1.0 /5

Civil / Site: **Good Condition**

Structural: **Good Condition**

Proc. Mech.: **Good Condition**

Instrument: **Good Condition**

Proc. Elec.: **Good Condition**

Build. Mech.: **Good Condition**

Build. Elec.: **Good Condition**

Overall rating 'B' is due to a high Total Facility Risk and its criticality to the system and not its condition.

- 1) Condition assessment required to establish upgrade requirements.

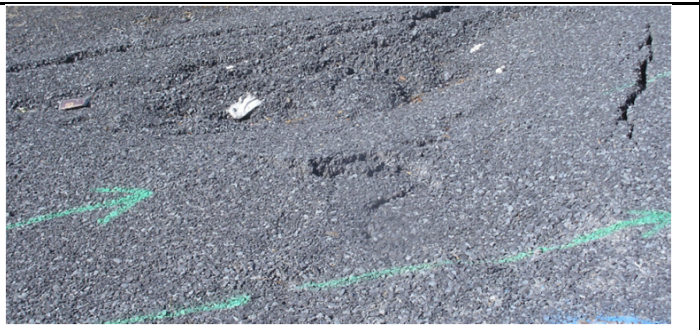
## 7.4.4 Tower Street EST

Reliability Rating	21.4	Overall Rating	C
Total Facility Risk	3.8 /5	Total Equipment Risk	2.7 /5
		Condition rating	2.1 /5

Civil / Site: **Chain Link Fence and gate - Good Condition**  
**Gravel Driveway has potholes from recent construction.**

Structural: **Tower, accessways & Ladders/Stairs - good condition.**  
**Control Room - Good Condition but aging. Accessway to valve pit - difficult to gain entry.**

Proc. Mech.: **Actuated Valve - corrosion present on valve body and actuator aged beyond design life.**  
**Piping in good condition**

Build. Mech.: **Good Condition, but aging.**

- Priority Work:**
- 1) Repair Potholes in driveway ( \$ 2,000 )
  - 2) Replace Sump pump in valve pit ( \$ 2,000 )
  - 3)

- 1) Replace Building Mechanical, Actuated Valve and manual valves.

- 1) Replace - Instrumentation, Process Electrical and Building Electrical.
- 2) Consider upgrading control room structurally (Price not Included)

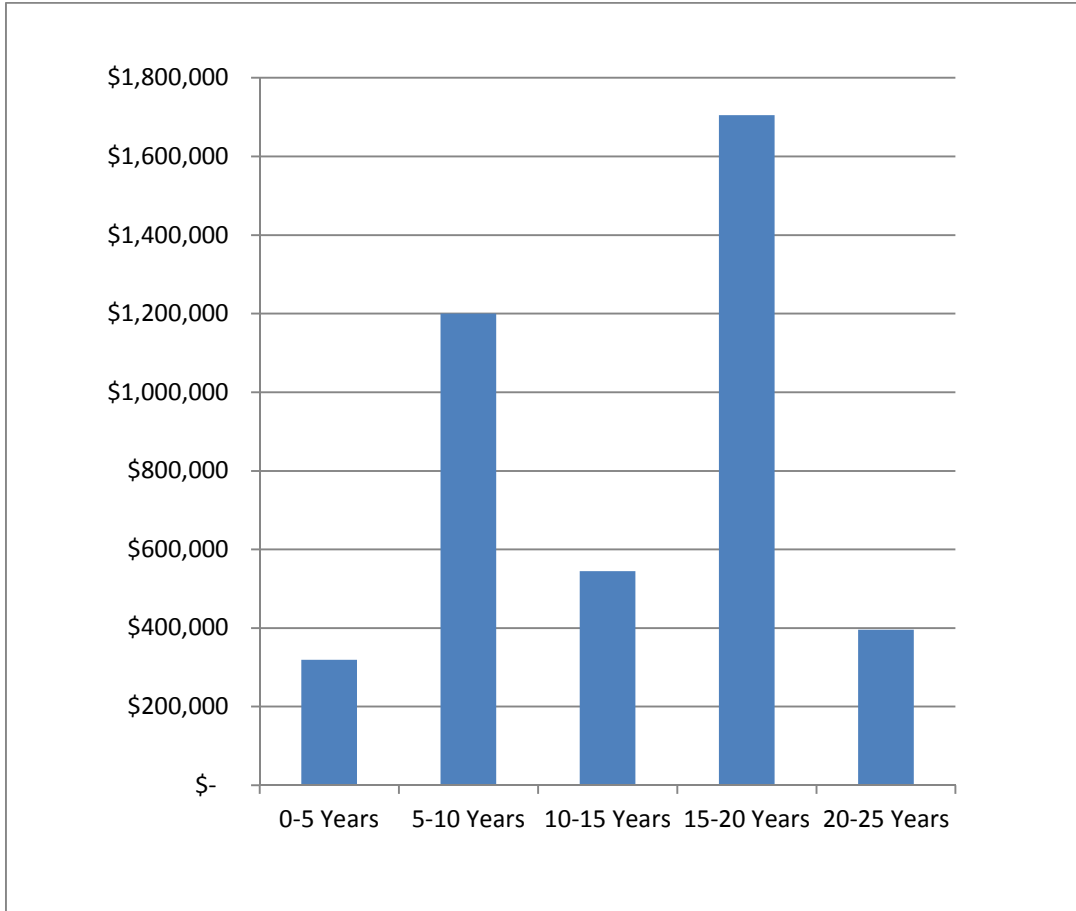
**Figure 8-1 Estimated Cost of Capital Improvements (0-25 Years)**

As can be seen from the graph in Figure 8-1 below, the cost of capital improvements is spread across all five year periods from 0 to 25 years. This is due to an array of years of construction or last upgrade of the facilities and the life-time of the components, with the concentration of expenditure falling in years 15-20.

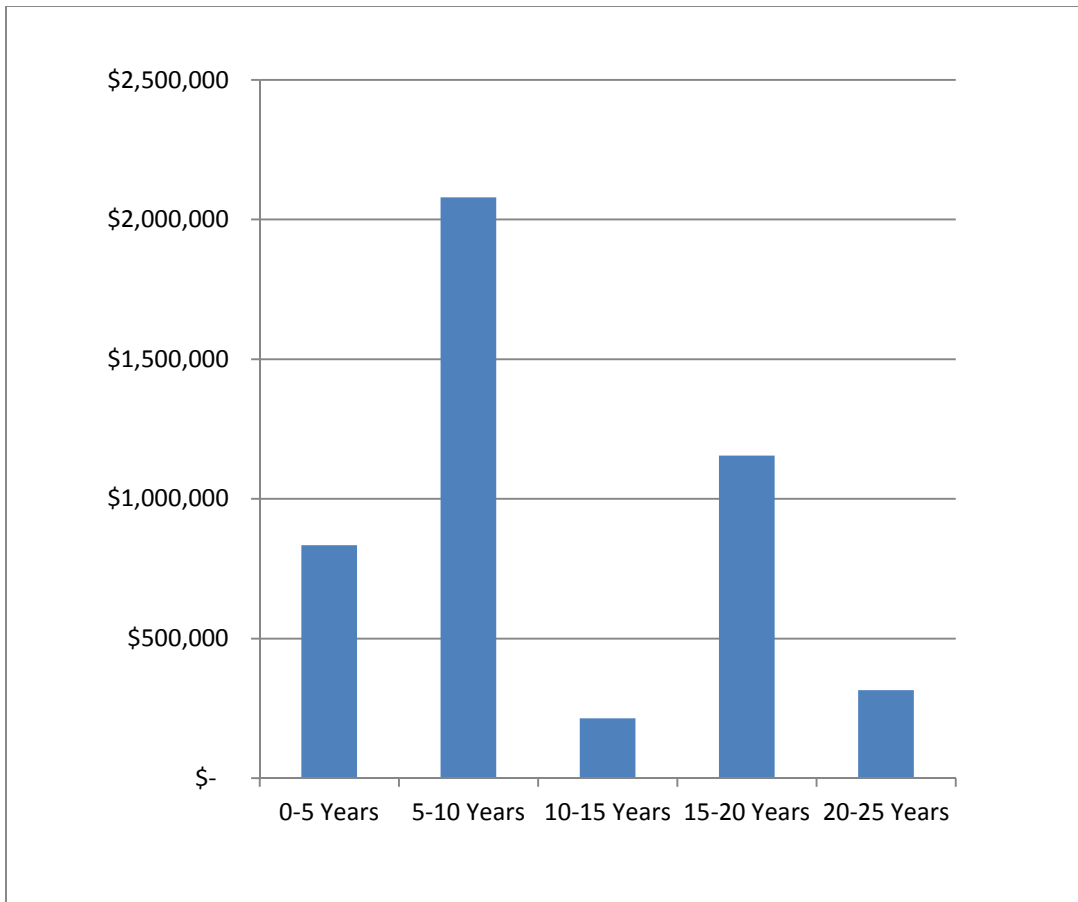
**Figure 8-2 Estimated Cost of Capital Improvements for PS (0-25 Years) - Rebalance of Expenditure**

Figure 8-2 below shows a the combination of similar upgrades as indicated in the Condition Assessment Sheets (i.e. consider upgrade 2 during upgrade 1 due to similar type of work). This approach provides a better value by combining upgrades, and reduces the general requirements that are typically carried in most contracts. This reallocation includes completing all three upgrades at the James Street Booster Station and both suggested upgrades at Third Avenue Booster Station in the 5-10 year time step and completing upgrades 1 and 2 at the O'Connor Drive EST in the 10-15 year time step. While this does not provide a more balanced expenditure, it does provide better value for Utilities Kingston.
